A TRIO OF FRENC PART 1 of 3 Determinants Deter

CH IRON CLOCKS 'I Prowent'_ by John Robey, UK

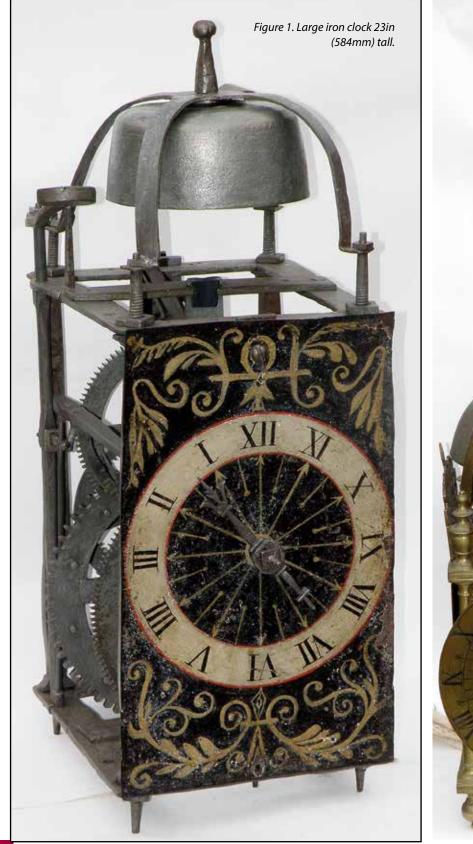
The first clock, shown in **figure 1**, has already been the subject of an article in *Antiquarian Holorogy* in March 2012, but further research has helped explain its most obvious eccentricity and its origins are now likely to be a thousand kilometres from where it was once thought to have been made. Frustratingly it is one of the few Continental iron clocks that bears a name, but it is one that has not proved possible to trace (so far). This name

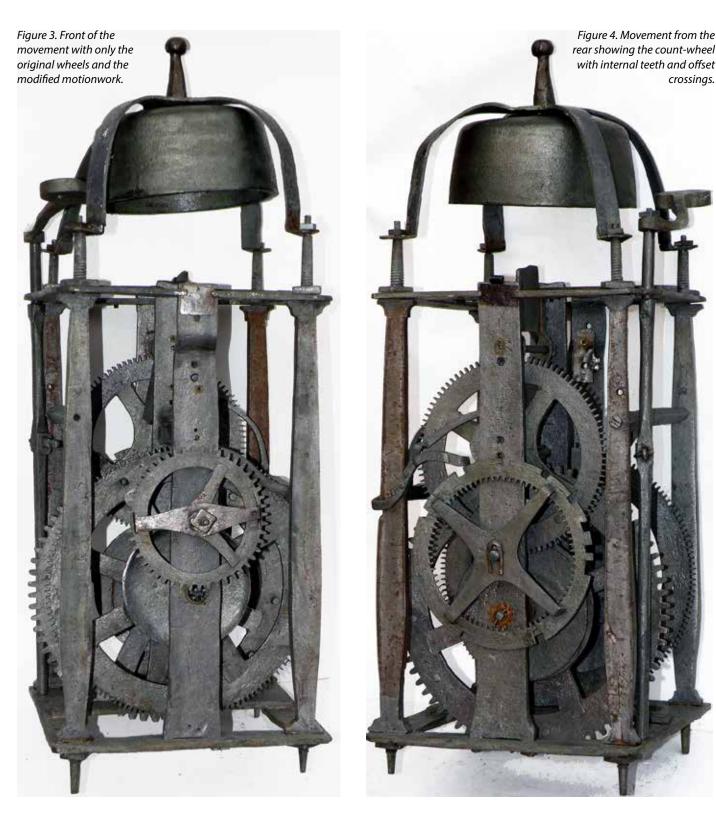
The massive posted-frame movement, figures 3-6, has forged top and bottom frames that form square open 'plates', which are held on to the baluster-shaped corner pillars with square nuts, figure 7. There are no separate feet, the clock standing on short extensions of the screwed lower ends of the pillars. The extensions at the top are longer with smaller diameter screwed ends on to which the iron bell stand is held with square nuts. The bell is held by a square nut screwed on to the bottom of a forged ball-topped finial. The movement bars are held between the top and bottom frames with two lugs and a wedge, in the typical manner used by English and French postedframe clocks. The central bar is fixed ----

Some time in the later seventeenth century or early in the following one the balance was replaced by a verge escapement and a short pendulum. This involved replacing the crownwheel with a contrate wheel and adding a new escape wheel above the top plate. Both the original bridge on the central movement bar and the later bottom support for the new crownwheel just above it, can be seen in figure 5. When an English lantern clock was converted

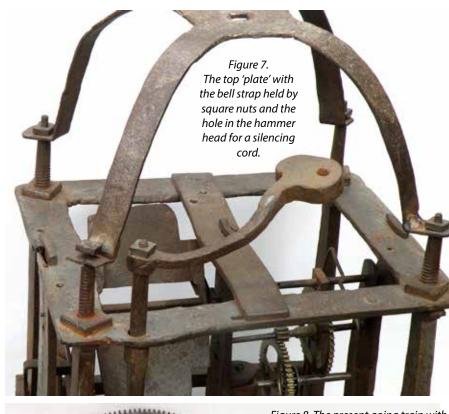
Figure 8. The present going train with the original iron great wheel and rope pulley, and the later tic-tac pallets, wire pendulum rods and brass wheels. Note the pin to lift the nag's head.

Later still—probably some time in the nineteenth century—the verge pendulum was replaced by the present tic-tac escapement, **figure 8**. Now, the escape wheel was below the top plate and the fly and other parts of the striking train prevented the pallet arbor from extending to the rear of the movement with a pendulum swinging outside the rear of the frame. To avoid having to virtually rebuild the clock, the new pendulum consisted of two wires straddling the arbors. Though there are now no bobs, it is likely that there would have been a small one sliding on each wire. Not only would these allow the clock to be regulated, but by adjusting one relative to the other a simple method of setting the clock in beat could be provided.

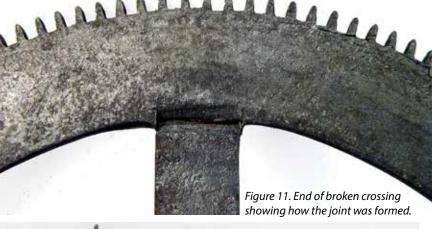
Conventional crossings prevent -----

the engagement of the pinion leaves with internal teeth, so the crossings have to be offset and the forged-over ends riveted to the face of the wheel rim. This causes no problem for a count-wheel of this construction, and it would have been guite satisfactory for a dial wheel until the escapement was updated. When the balance was replaced by a verge pendulum it was not so easy to disengage the pallets from the escape wheel to reset the hand. This would have been quite possible by having long pivots so the verge could slide horizontally, with a swivelling end stop to prevent unintentional disengagement. Indeed, this was a popular method with some turret clocks with an anchor escapement during the eighteenth century.

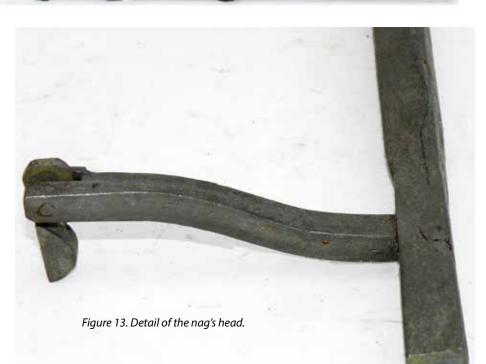
Figure 14. The original XI revealed beneath the later anti-lockwise hour numerals.

This brings us neatly to the problem of the anti-clockwise hour numerals. which are related to the strike let-off and the motionwork. When the article in Antiquarian Horology was published it was not known for certain that the chapter ring had been altered, though this seemed highly likely. Paint analysis showed that there was a pigment that suddenly went out of use about 1650, indicating an early date. It also revealed that there were three different schemes: the original and two over-paints, but this could not reveal the earlier designs or the original Roman numerals. It was decided that only removing the top layers of paint over the II would settle the issue. This revealed that originally XI was underneath, figure 14, so the numerals and the hand rotated in the conventional clockwise direction.

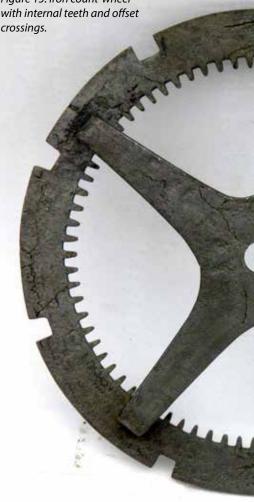
Figure 15. Iron count-wheel with internal teeth and offset crossings.

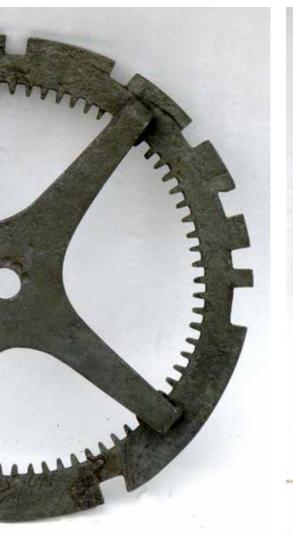
Figure 16. The later hour wheel and friction spring for the hand.

With a fixed hand and no means of disengaging the pallets, the only means of setting to time is by stopping the clock and restarting when the hand shows the correct time-very inconvenient. The simplest method would have been to fit the hand on a short pipe which was a friction fit on the pipe of the hour wheel, and this would not have interfered with the internal teeth and offset crossings. Instead the motionwork, figure 16, was altered and rather than being fixed directly to the arbor of the hour wheel the hand was fitted to a friction spring that bears on the hour wheel. But this introduces yet another problem: the offset crossings get in the way. The solution was to replace the hour wheel with internal teeth and offset crossings with a conventional wheel with flat crossings and external teeth, figure 16. This new wheel, like the originals, is made of wrought iron with separate crossings and rim (though not joined in the same way) and indicates that these changes took place at an early date, probably in the late seventeenth century when the clock was already about a century old.
