REPAIRING AFUS t is always a satisfying to repair a

by John Robey, UK

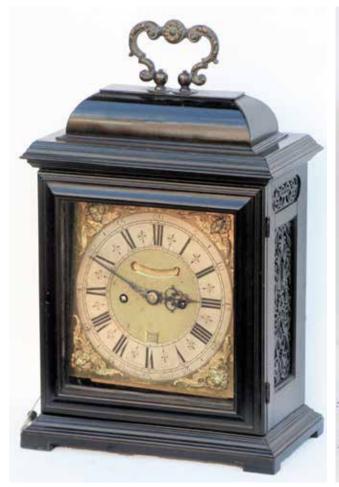
Figure 1. Early eighteenth-century ebonised bracket clock.

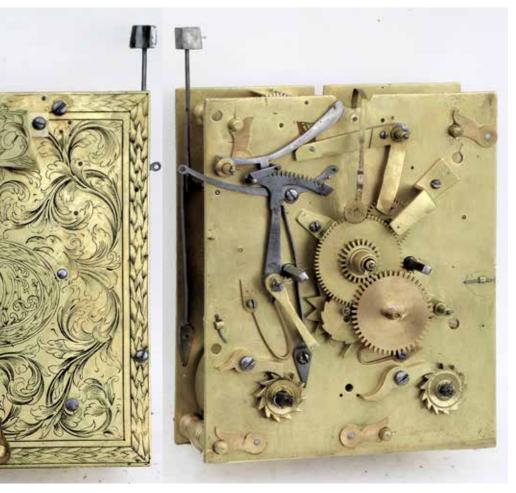
Figure 3. The movement with rebuilt strikework.

be very varied and individualistic, it is often virtually impossible to determine what had been there to start with, so rebuilding it with hour striking using a conventional rack and snail system had been the most pragmatic solution, figure 3. The owner was quite aware of all this and accepted it as a goodlooking clock that fitted well into his period home.

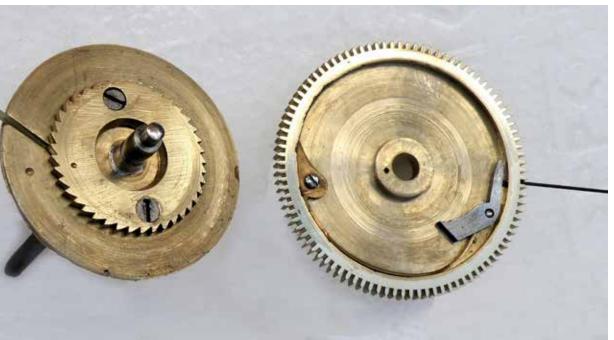
Figure 4 (far left). The enclosed type of fusee used in the nineteenth century.

Figure 5 (left). A separate ratchet is screwed to the fusee with the click and spring fitted on the fusee wheel. Note the wire on the right demonstrating how the click may be released from the outside.

The diagnosis proved to be correct -a faulty click spring was the problem. But this was not going to be a straightforward repair. Early fusees are constructed in a different manner to those on later clocks. There are two types of fusees: the later type with enclosed ratchet teeth and clicks and earlier ones where they are exposed. Bracket clocks and English dial clocks from the nineteenth century have a separate ratchet that sits inside a recess in the body of the fusee and is held in place with two or more screws. figures 4 to 5.

The click and its spring are fixed to the fusee wheel so when assembled all the click mechanism is enclosed and ingress of dirt is prevented. Often the click is a simple affair with no

tail, but on quality clocks there may be a tail and a small radial hole drilled in the wheel rim between two teeth. This enables a thin wire to be used to depress the tail and disengage the click from the ratchet. The main use of this was to let down the mainspring in stages when using a set-up tool, instead of the more risky procedure of releasing the set-up click a tooth at a time

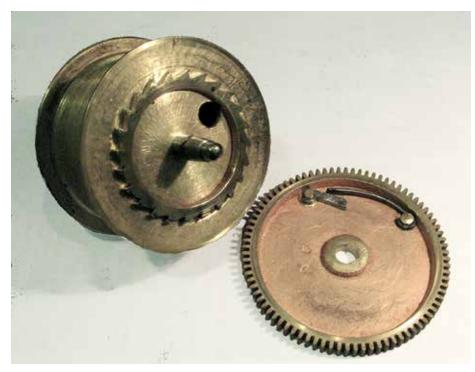
Figure 6. Internal click on the barrel of an eight-day Deacon longcase clock.

Samuel Deacon, the well-known Leicestershire clockmaker, used a very similar enclosed click system on his eight-day longcase clocks, but without the ability to disengage the click from the outside, figure 6. In theory this is a superior system that protects the ratchet and click, but there are practical disadvantages. If the line becomes tangled or needs replacing there is no hole between two teeth to disengage the click (it would probably be in an inaccessible position anyway). Feeding the free end of the line back off the barrel might solve the problem. but if it is wrapped tightly round the arbor or if it is on the centre barrel of one of Deacon's three-train musical clocks then dismantling the whole movement is the only solution. Since Deacon was very keen on parting his customers from their money, it is likely that this was a deliberate ploy so that they had to pay for a strip-down, which could be avoided with a conventional longcase movement having an open ratchet and click

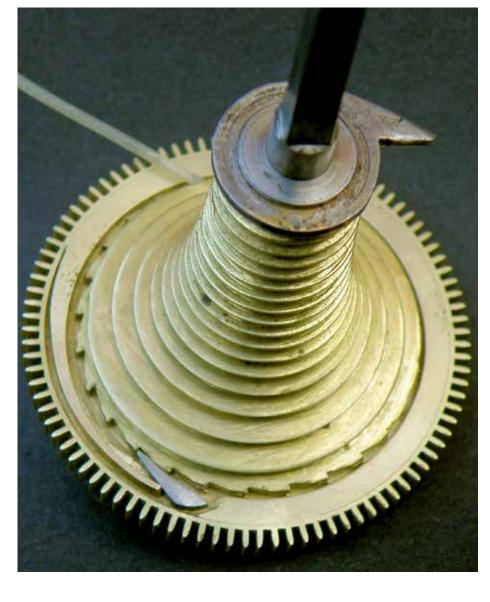
Figure 7. Early type of open fusee with the ratchet teeth cut into the edge of the fuse and the click spring part of the wheel (shown after repair).

The fusee of this bracket clock is of the early open type where the ratchet teeth are cut round the edge of the fusee itself with the click and its spring recessed into the wheel, figure 7. The spring is of a particularly neat and elegant construction and at first glance it appears to be impossible to make it. In fact the spring is a brass ring that fits so closely inside a recess in the wheel that no join is visible and seems to be part of the wheel itself. A crack can be seen in the old spring, figure 8, but it would be difficult, though not impossible, to repair it satisfactorily. This is an instance where making a new part is preferable to trying to repair it. But making a new spring for this type of fusee is not as straightforward as for the later enclosed type. With careful planning and accurate machining a perfect replacement can be achieved.

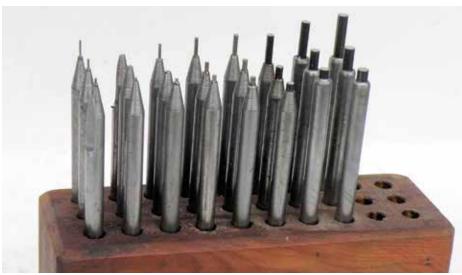
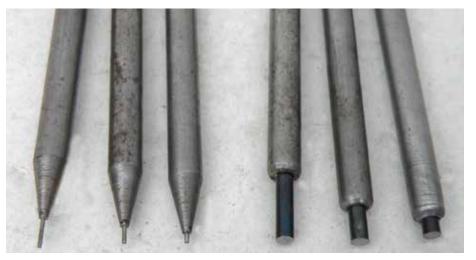
Figure 11. A watchmaker's staking tool (right) and the larger versatile JMW staking tool (left).

The other route to disaster is to use them freehand—instead hold them vertical in a in a staking tool to ensure a straight blow. One of the larger sizes of watchmaker's staking tool is suitable for small items like this, but for larger work the very versatile staking set made by JMW Clocks in Sheffield is well worth the investment, figure •••

11. If the punch jams in the hole it can be very difficult to remove it from a traditional watchmaker's tool, but the upper arm on the JMW tool can be swung to the side allowing removal of the punch.

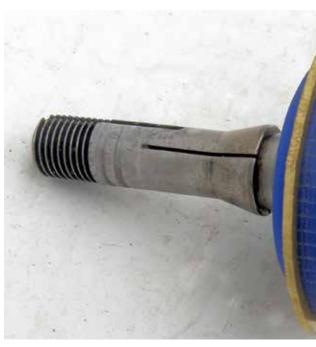
Figure 12. Brass disc held between Perspex backing discs in a mandrel made from an old collet.

Centre punch and scribe the inner and outer diameters with dividers. The ring could then be cut out with a piercing saw and held in a three-jaw chuck using first the outer jaws and then the inner jaws. But by doing it this way there is the probability that the ring will distort and it will not fit snugly in the recess in the wheel. A better approach is to drill a central hole to fit the blank on a mandrel, **figures 12** to **13**, as if you were making a clock wheel. This type of mandrel has been described many times before, and the one shown here was made by silver soldering a mild steel bar into an old redundant W12 collet and turning a spigot and clamping thread on the

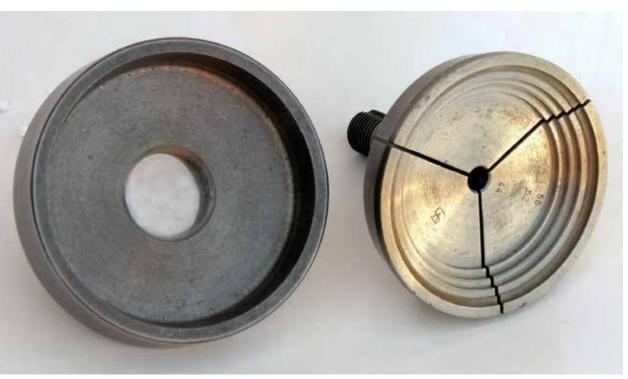
Figure 14. W12 step collet and closer.

Then cut out the centre and hold the ring by its outer edge. Ideal for this is a step collet of the correct size, figures 14 to 15, or a six-jaw bezel chuck. Since it has no moving parts a step chuck is the most accurate, but each

one can only accommodate a limited range of diameters. A bezel chuck can grip a much wider range of sizes, though with slightly less accuracy, and would be a more useful alternative. Failing either of these, mount a block of aluminium alloy, brass or even hardwood in a three- or four-jaw lathe chuck and turn a recess into which the ring fits firmly, if necessary holding it with shellac or a removable adhesive. Since the inner diameter of the spring is not critical an alternative would be to carefully file to the inner scribed line.

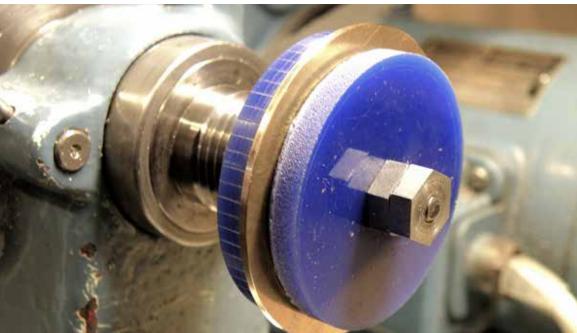
Figure 13. The mandrel held in the headstock spindle of a Schaublin SV70 lathe.

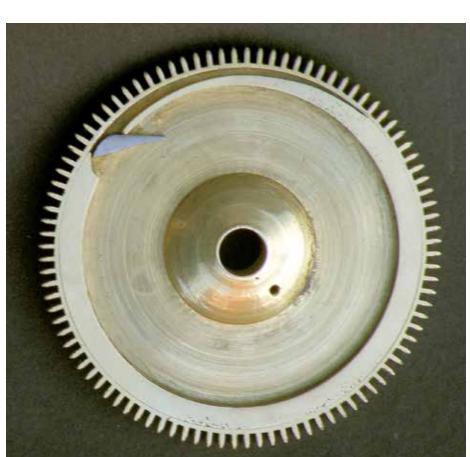
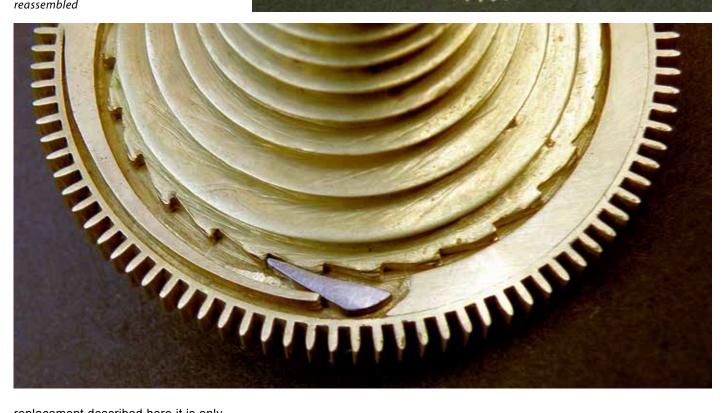
Figure 18 (below). Job done and fusee reassembled

The other (striking) fusee of this clock had had a similar spring replacement by the previous restorer and the join was obvious while on the

replacement described here it is only just discernible, figure 17 to 18. This makes no difference to the spring's operation, but it is satisfying to make a good neat job.
