## Mayhew's hoop-and-spike clock

## by **John Robey**, UK

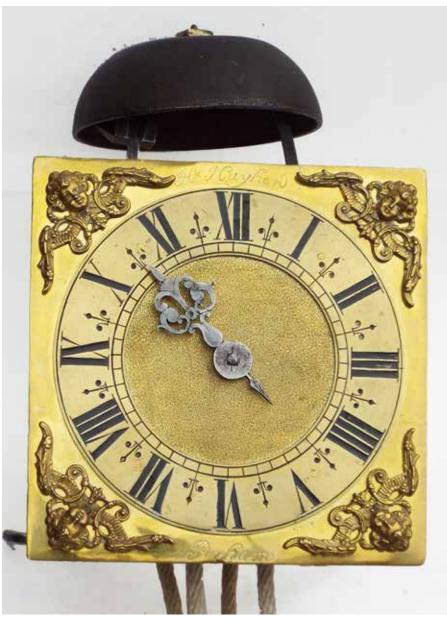
Figure 1. The small Mayhew dial, only 7in wide.

(178mm) wide and 71/4in (184mm) tall, with a plain matted centre, small cherubhead spandrels and a single iron hand, **figure 1**. The chapter ring is not silvered and this is how it may always have been. It is signed rather naïvely 'Hy. Mayhew' between the top two spandrels and 'Parham' at the bottom.

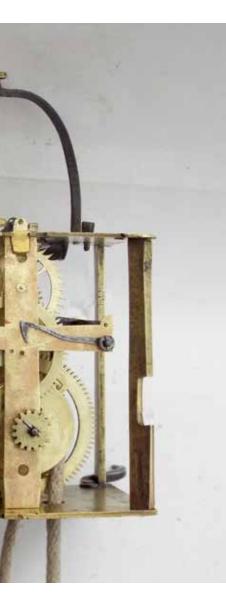
Figure 2. Dial rear showing the original tabs and later dial feet.

The dial was originally fixed to the movement by the usual lug at the bottom sitting in a hole in the bottom plate, and at the top by two tabs held by screws to the top plate. At some stage this was not thought to have been sufficient, despite it having been used successfully on thousands of clocks. The lower lug had

been bent to one side and two dial feet added, **figure 2**, that passed through holes in the front movement bar. The tabs at the top continued to be used, so the dial is now held very firmly by its 'belt-andbraces'.

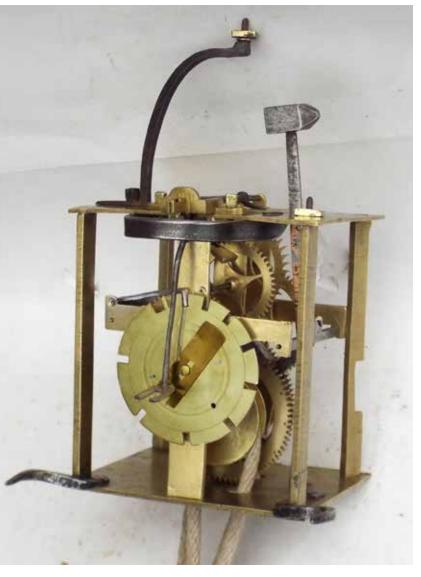
Figure 5. Rear of the movement.

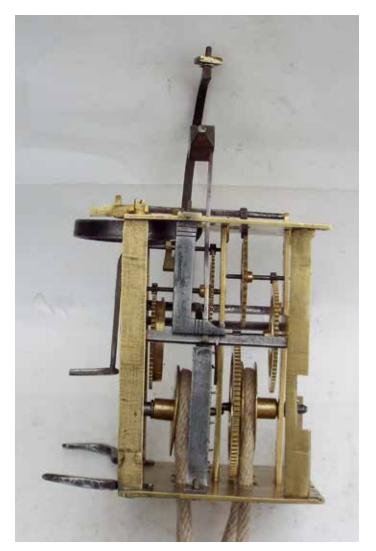
Figure 6. Left-hand side of the movement.

rectangular cross-section. The rear pillars are riveted to the plates with the wider side parallel to the plate sides, while the front pillars are at an angle to the edges. In addition the front pillars have, for some unknown reason, large sections filed away, figures 3 and 4. The left-hand arm of the front bar has a hole drilled that does not seem to serve any useful purpose. There is much more backlash or 'shake' on the hand than would be expected, being about 15 minutes. No doubt this was of little concern for an early eighteenth-century Suffolk farmer without a rigid timetable to follow. The wheelwork is quite conventional, with three wheels in each train having parallel arbors and brass 'cheese-head' collets, rather than the wheels fitting directly on to tapered arbors, figures 6 and 7, which was the method used on earlier clocks.

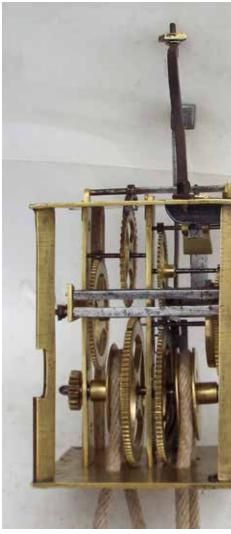
Figure 7. Right-hand side of the movement.
