Prototype lantern clocks. Part 2: Newly discovered clocks

Antiquarian Horology, Volume 44, No. 1 (March 2023), pp. 23-33

Prototype lantern clocks Part 2: Newly discovered clocks

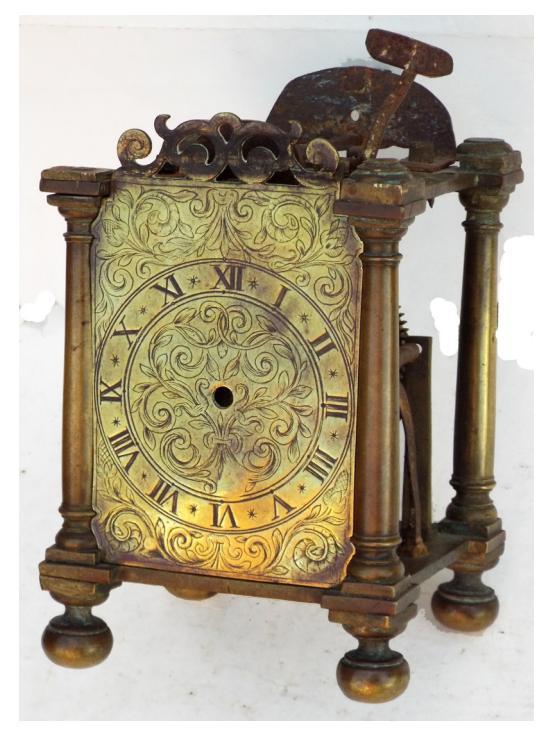
Fig. 10. The Skelton clock as found.

It is a miniature clock, approximately threequarters the size of an early-seventeenthcentury standard London clock. The plates are only 4³/₆in (104mm) square, and pillars 4¹/₈in (103mm) between the plates with a singlesheet dial just 3¹/₈in (78mm) wide and 5¹/₈in (130mm) tall including an integral fret (Fig. 11). It is engraved in late-Renaissance style, probably inspired by a design in one of the many printed pattern books that circulated freely throughout Europe in the sixteenth century.²⁷ The centre and top of the dial are filled with stylised acanthus-like leaves and scrolls, while at the bottom they terminate in spiral stems. The top and sides include hatched

The finials had been cut off, the bell and strap, hour wheel and hand were missing. Despite these losses the remainder of the movement is in remarkably original condition with only a few alterations.

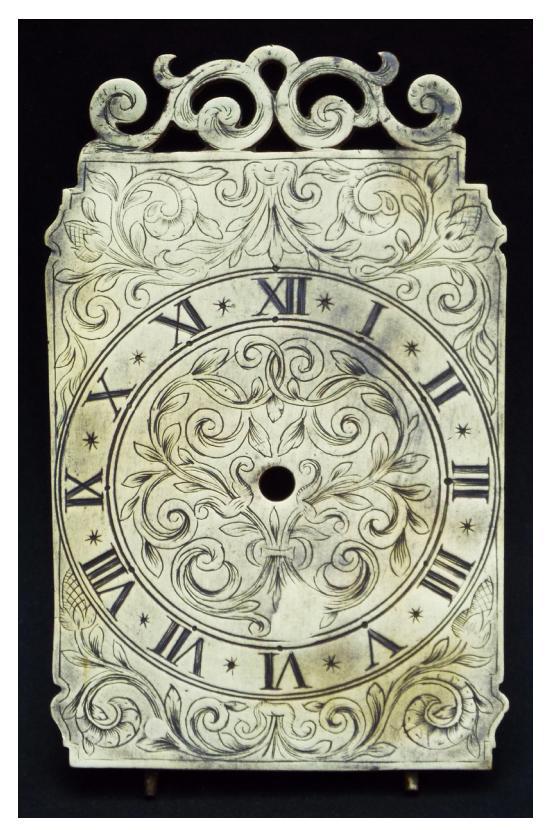
Fig. 11. The single-sheet brass dial with an integral fret.

flower buds representing seed pods. The fret is in the form of double S-scrolls. The chapter ring has simple half-hour markers in the form of small stars, without quarter divisions, as is usual on both Continental clocks and early English lantern clocks. The dial is held by two brass lugs riveted to the rear and fitting into holes in the bottom plate, with a long lug at the top fitting in a square hole in the front movement bar and held by a taper pin.

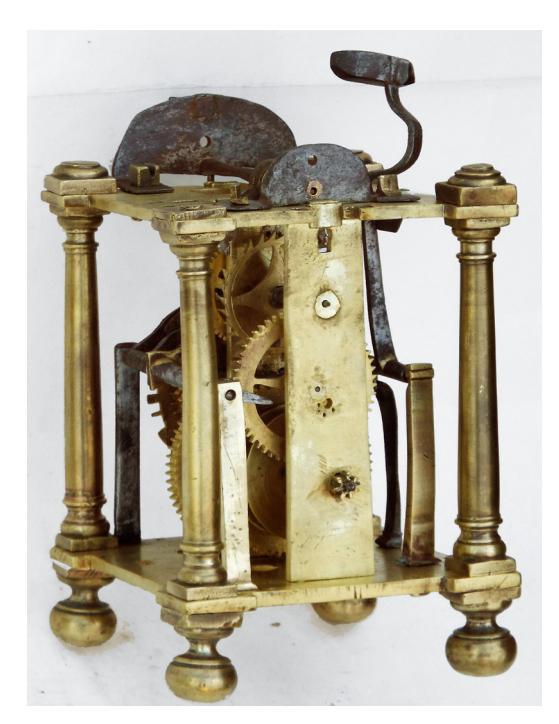
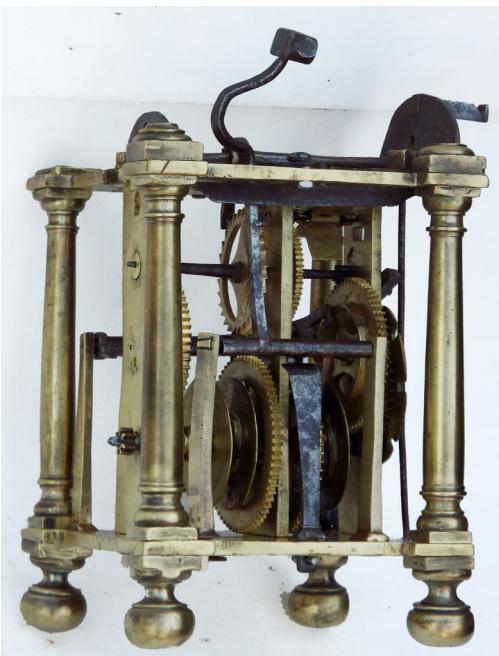
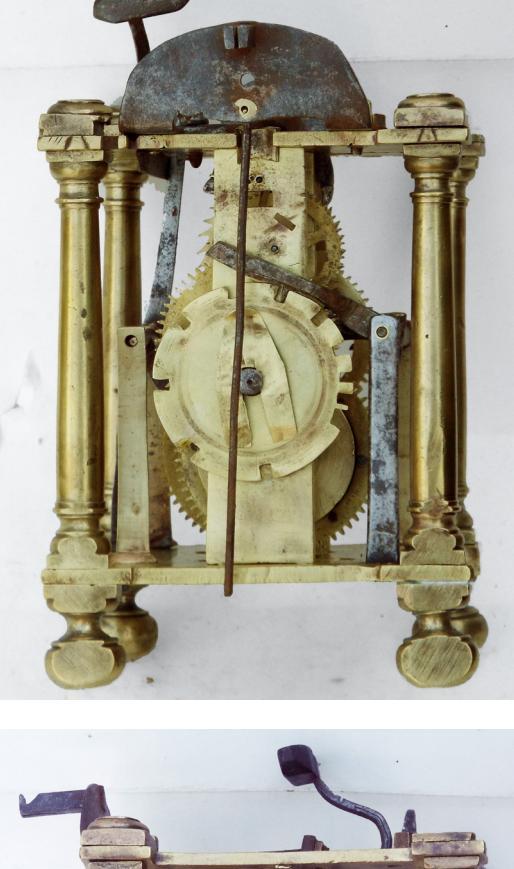
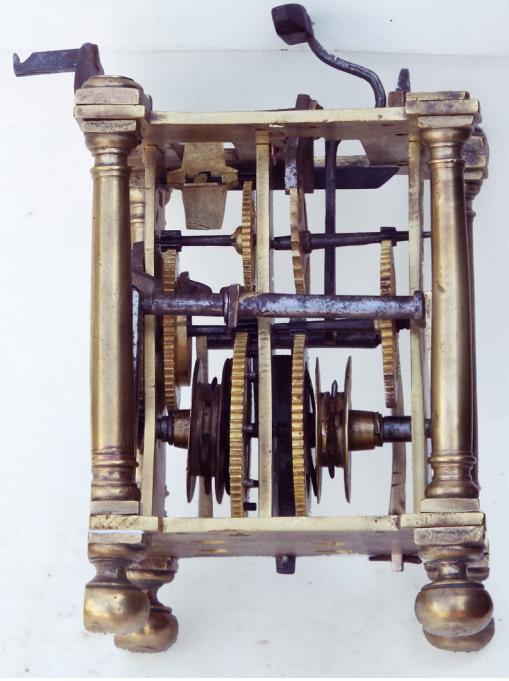
Figs 12-15. The movement after cleaning. There is no hoop or spikes for hanging on a wall.

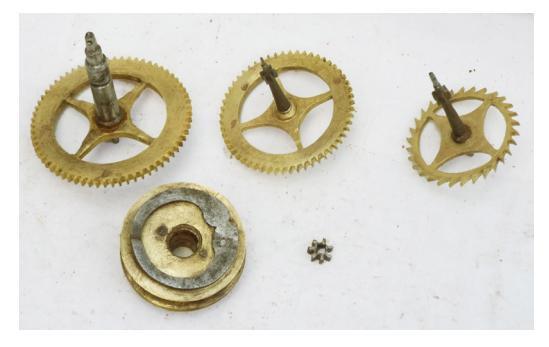
Fig. 18. The going train with a later escapewheel and pinion-of-report.

The wheels of both trains (Figs 18–19) are of the usual construction, and fit onto tapered arbors. There is no sign of a rear extension added to the arbor of the later anchor escapewheel so it (with a small integral iron collet) is probably a replacement. Two other arbors have small brass collets and while these are not usual on early clocks there is no evidence that they are replacements. The hoop on the locking wheel of the striking train is an integral casting, rather than a separate hoop as used on later larger clocks, sometimes made of iron. A significant component is the cast fourvane fly (Fig 20), only known on one other English lantern clock, which, despite having lost its dial it can be identified as probably having been made in the Harvey workshop about 1610.28

The counts (with replacements in square brackets), which differ from those usually found on later larger clocks, are:	
Going train escapewheel 2nd wheel greatwheel dial wheel	$ \begin{bmatrix} 30 \\ - \end{bmatrix} - \begin{bmatrix} 6 \\ 58 \\ - \\ 6 \\ 70 \\ - \\ \begin{bmatrix} 7 \\ \end{bmatrix} \\ \begin{bmatrix} 42 \end{bmatrix} $
Striking train fly warn wheel hoop wheel greatwheel (8 hammer pin countwheel	$ \begin{array}{rrrrrrrrrrrrrrrrrrrrrrrrrrrrrrrrrrrr$

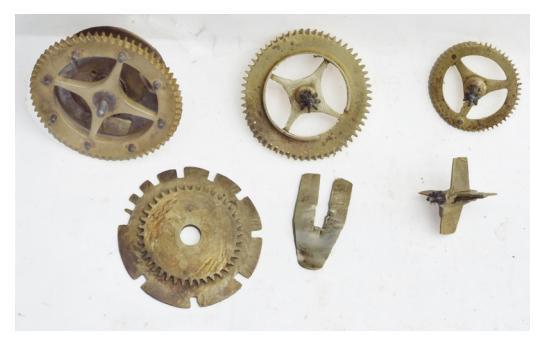
Fig. 19. The striking train.

While early Harvey clocks have, where original, a separate four-leaf pinion-of-report, it is likely that this one originally had an integral four-pronged pinion. The striking pinion retains its original four pins, but the going one has been changed to a separate seven-leaf brass pinion during the conversion to a verge pendulum. This involved fitting a new going greatwheel arbor with a square at the front. However, it is too long and instead of reducing its length the dial was punched from the rear by an incompetent clockmaker, resulting in the loss of a small area of engraving. The train pinions have probably been re-profiled to compensate for wear, rather than having been

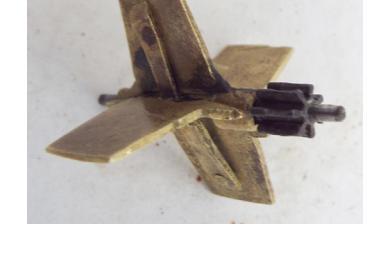
Fig. 20. The four-vane fly.

• a four-vane fly — only known on one other lantern clock, later clocks had a small heavy fly

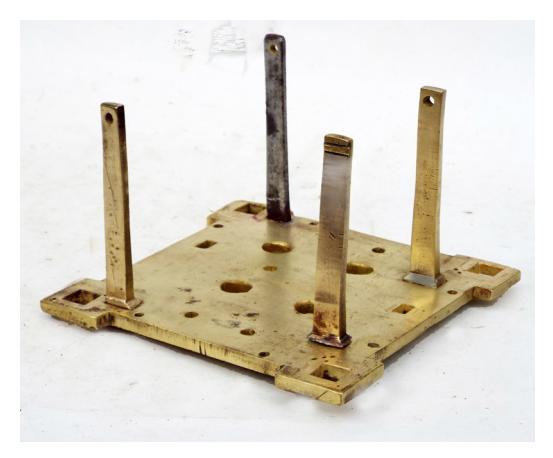
Fig. 21. Bottom plate with two pairs of vertical supports for the strike-work and hammer arbors. Note the recessed sides of the plates and the square holes for the lower ends of the pillars.

The most significant technical features involve the strike-work and hammer, in particular how they are supported. If their arbors had been pivoted in the pillars, as usual on Continental clocks, they would have been fouled by the recessed side panels. Hence these arbors have to be positioned in-board of the pillars. On the Skelton clock this is achieved by pivoting them in two pairs of vertical brass supports (Fig. 21), a method that has parallels on some Flemish clocks and later French clocks,³⁰ but is unique to English clocks. Each pair has (or had) one support riveted to the bottom plate, the other one being removable and held in place by a taper pin to facilitate assembly of the arbor. The pivot hole in the removable support for the hammer arbor has a dovetailed end stop. Removing it allows the extended pivot to slide forward, thus providing another means of removing the hammer. This is not known on any other lantern clock. The

removable support for the strike-work has been replaced in iron and riveted in place. Despite a shoulder where these supports fit into the plate their footprint is not large enough. It proved unsatisfactory and was replaced on later clocks by the now familiar side arms on the front and rear movement bars — a system that was so successful that it continued into the nineteenth century on English posted-frame longcase movements.

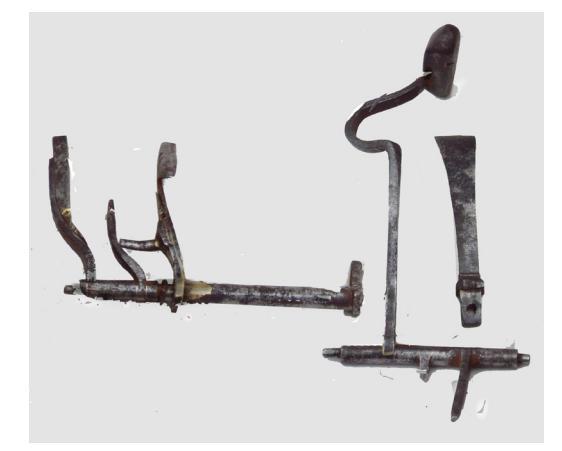
Fig. 22. The concentric strike-work (left), hammer and hammer spring.

Instead of the two arbors for the lifting/warning and locking/countwheel detents being pivoted separately, on this clock they are concentric, with the lifting/warning detents on a pipe that sits over the pivoted locking/countwheel arbor (Figs 22–23). This arrangement is not known on any other English clock, but was occasionally used on seventeenth-century and later French clocks.³¹ It is not a particularly efficient system as the large friction between the pipe and the arbor is liable to prevent the detents from falling freely. Both the pipe and the arbor originally had flat springs to prevent sticking, but these must have proved unsatisfactory as a heavier rather crude arm was added to the

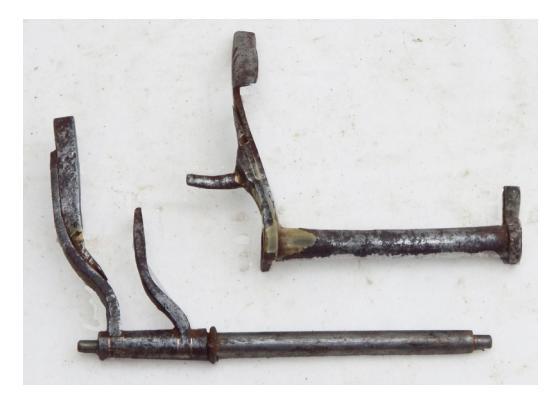
Fig. 23. The warning/lifting detents (top) sit over the locking/countwheel detens (below).

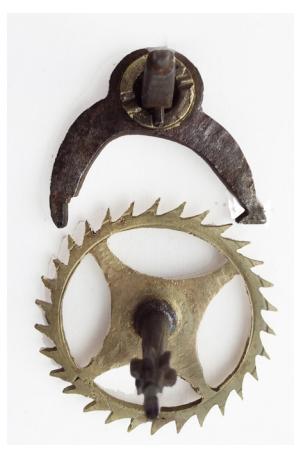
Fig. 24. The very early anchor escapement, added about 1675-1700.

The pallet arbor of the even later anchor escapement pivots between large front and rear iron cocks each held by two square-headed brass crews. The shape of the anchor pallets (Fig. 24) suggests that the conversion occurred at an early date, possibly as early as 1675 and before 1700. The optimum position of the pallet arbor is a short distance above the teeth of the escapewheel, but on the Skelton clock long pallet arms are necessary to engage with the escapewheel teeth, resulting in a geometry that is far from ideal.

Any wear pits on the pallets had been filed away, producing a very large drop onto the entry pallet, which was reduced by refacing. However, while there is a reasonable impulse on the exit pallet there is very little lift on the entry pallet. It cannot be determined if the present pallet angle is similar to its original one, or is the result of filing at a different angle to remove the wear pits.

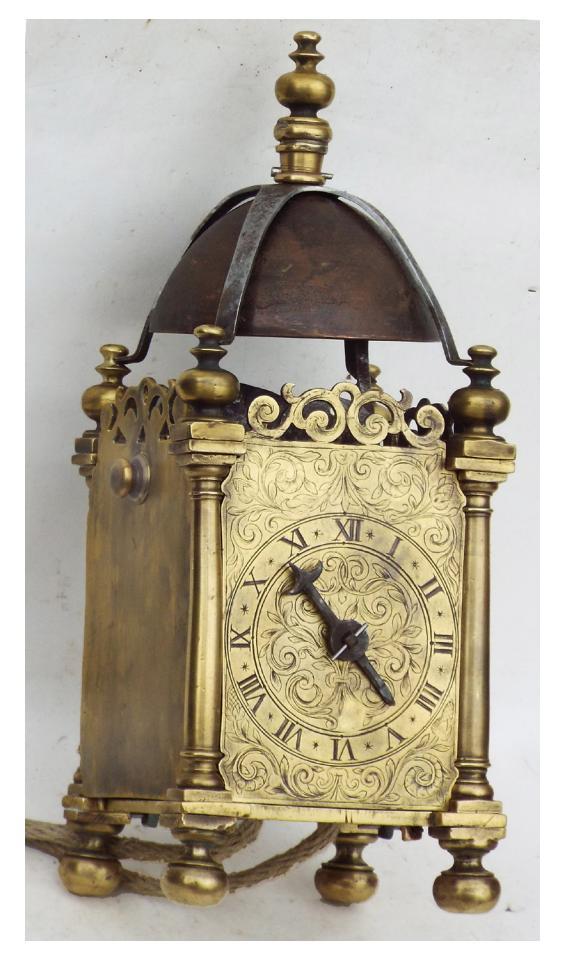
Fig. 25. The restored Skelton clock.

The owner requested that it should be sympathetically conserved with the lost parts restored, including the cut-off finials

and the missing bell and strap. The early anchor escapement was to remain and not be reconverted back to balance, the aim being to show how the history of the clock developed through the ages. The restored finials (Fig. 25) were based on a clock only slightly later (see below) with a lugged bell and wrought iron strap, giving a total height of $10\frac{1}{2}$ in (267mm). Removable brass side panels with integral frets and spring latches, as well as a wrought iron rear plate, were fitted; the motion-work and hand have also been restored. The pendulum, with 56.4 beats/minute, was fitted with a leadfilled spherical brass bob. All added parts can be removed if any of them are subsequently found to be incorrect.

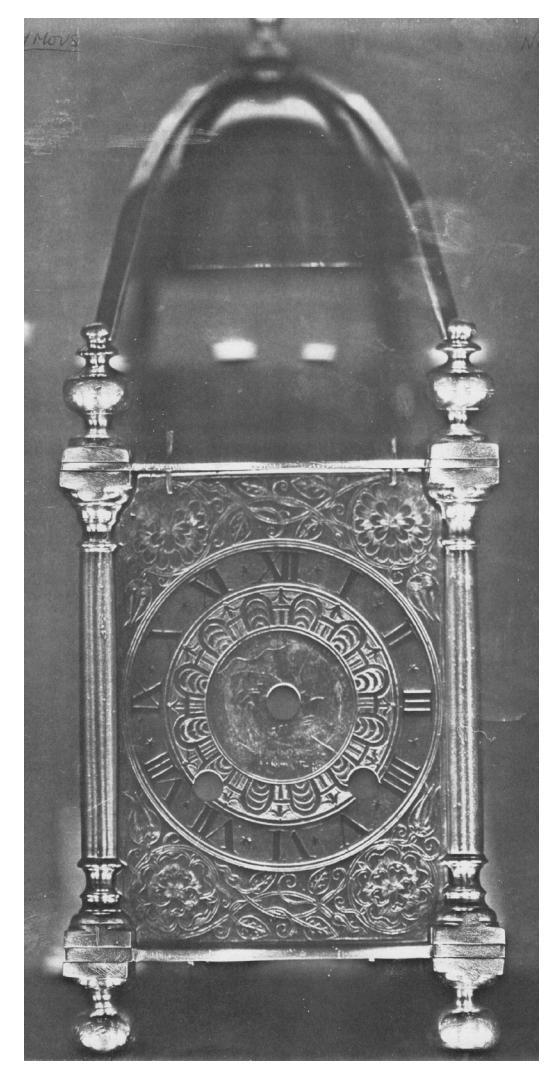
Fig. 26. The frame of an early clock from the Harvey workshop with a single-sheet dial. (Peter Harding courtesy of David Todd)

known that predate Robert Harvey's Little Britain clock. The first is only known from four photographic prints of photocopies (Figs 26– 29) of a clock frame and dial found about 1970 by David Todd in a junk box when working as a restorer for Meyrick Nielson, of Tetbury. For convenience it is referred to as the Todd clock.³² It has previously only been known from the image of its dial and a drawing of the

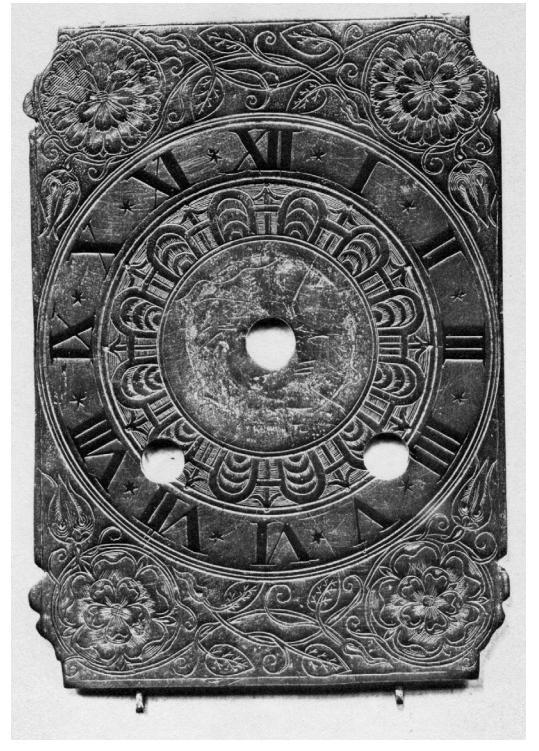
Fig. 27. The dial with floral corners and gadrooning in the centre. The alarm-setting disc is missing. (Peter Harding courtesy of David Todd)

Like the Skelton clock it has a singlesheet dial, and though its exact dimensions are not known it is said to have been about three-quarters the size of a usual lantern clock, hence it is likely to be the same as the Skelton clock. Only the frame, dial, bell and strap survive, with a later top plate and movement, which was probably from a small square French spring clock. The recessed sides and protruding corners of the original bottom plate identify it as having been made in the Harvey workshop. The top and bottom of the dial are engraved with flowers and serolling foliage, with a narrow band of gadrooning between the chapter ring and the space left

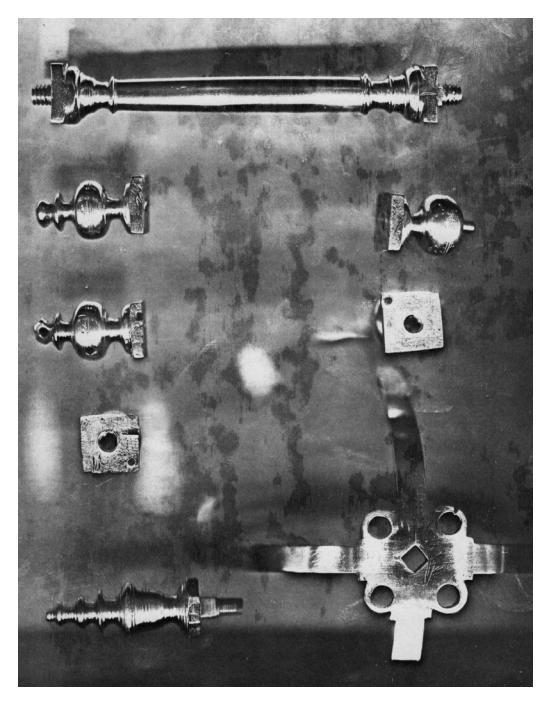
Fig. 28. Components of the frame. (Peter Harding courtesy of David Todd)

by the missing alarm disc. The bun feet are similar to those on the Skelton clock, while the finials are shorter and stubbier than on later clocks. They are attached by the same type of short integral brass threads as on the Skelton clock. The lack of four rectangular holes in the bottom plate indicates that the strike-work and hammer were supported in a different manner to the Skelton clock, possibly on cruciform movement bars, and hence it was made a little later than the Skelton clock.

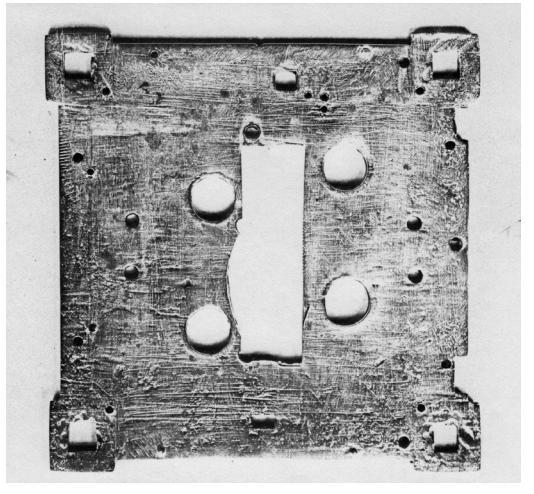
Fig. 29. Bottom plate with recessed edges, typical of the Harvey workshop. The square holes for the pillar spigots indicate integral brass threads. The large aperture is for a later spring movement. (Peter Harding courtesy of David Todd)

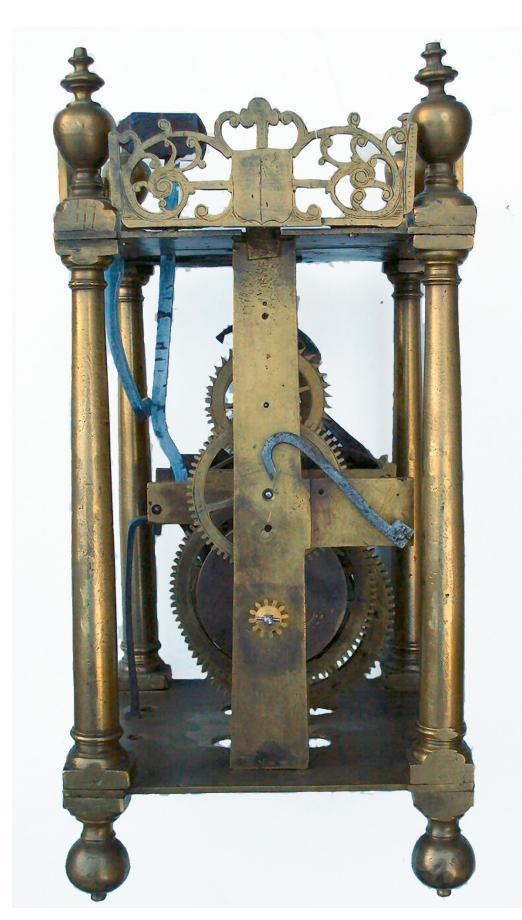
Fig. 30. Front of the giant clock as found. (Private collection)

A further prototype clock is now known, but instead of it being similar to the Skelton and Todd miniatures it is a giant clock (Fig. 30).

Rather than it being simply a scaled up version of the usual size of clock, it is proportionately slimmer. The frame is 15¹/₄in (387mm) tall to the top of the corner finials, making it 50 per cent taller than a Thomas Harvey clock of about 1616,³⁵ while the plates are 7¹/₄in (184mm) square, only 30 per cent wider. Its restored total height is 21in (533mm).

It has lost its original bell, strap, side frets, dial and hand. The plates have the Harvey type of protruding corners, while the pillars have integral brass threads to hold the ovoid finials and ball feet (Fig. 31), one of only three clocks known to have this type of fixing. The surviving original front fret is a larger version of that used on the Henry Stevens 1620 clock (see Fig. 6, Part 1), held by feet and taper pins in an identical manner to chapter rings (Fig. 32), this being a method not known on any other clock. There are holes for the pin hinges of now-missing opening doors, not latched side panels. The movement bars have side arms for pivoting the hammer and strike-work, but they are riveted in place, rather than being integral castings. The balance top cock was held by a pinned lug and the hammer spring by the familiar screwed nut.

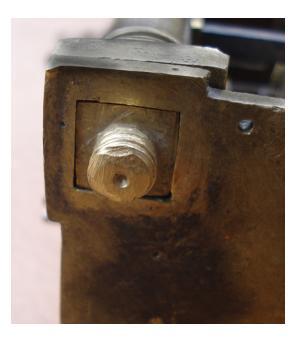
Fig. 31. Integral brass pillar threads to hold the feet and finials. (Private collection)

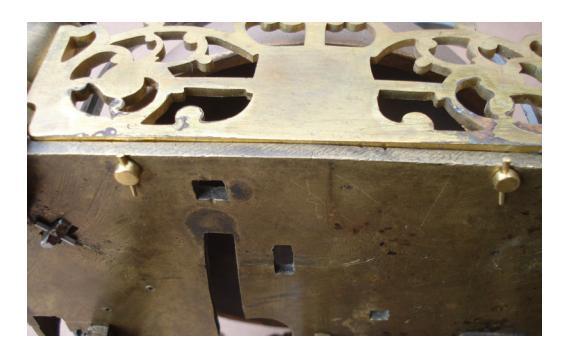
Fig. 32. The unique pinned feet to hold the frets. (Private collection)

The integral pillar threads and the pinned fret feet suggest that it was made just before Robert Harvey's Little Britain clock, while the use of doors instead of latched side panels, which were originally on the Harvey clock, suggest it is a little later. It was made at a time when these features were still being tried to determine the most suitable methods. The Skelton clock is almost certainly the oldest, followed by the Todd, giant and the Robert Harvey Little Britain clocks. Based on the design of the fret, finials and feet the owner
